Nationals
Date: March 30, 2023

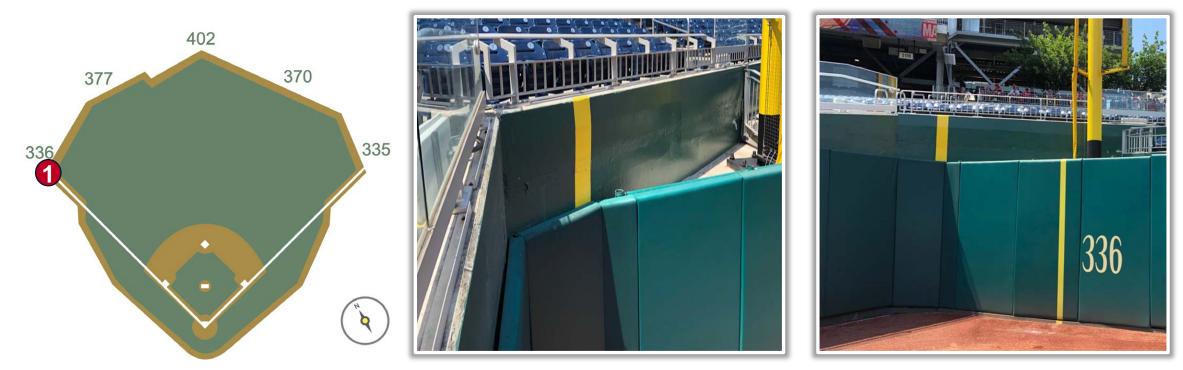
RULE #1: Fair bounding ball striking the metal safety railing in the left field corner above the green concrete wall that is between the foul pole and the angled plexiglass/railing down the foul line: **Out of Play**

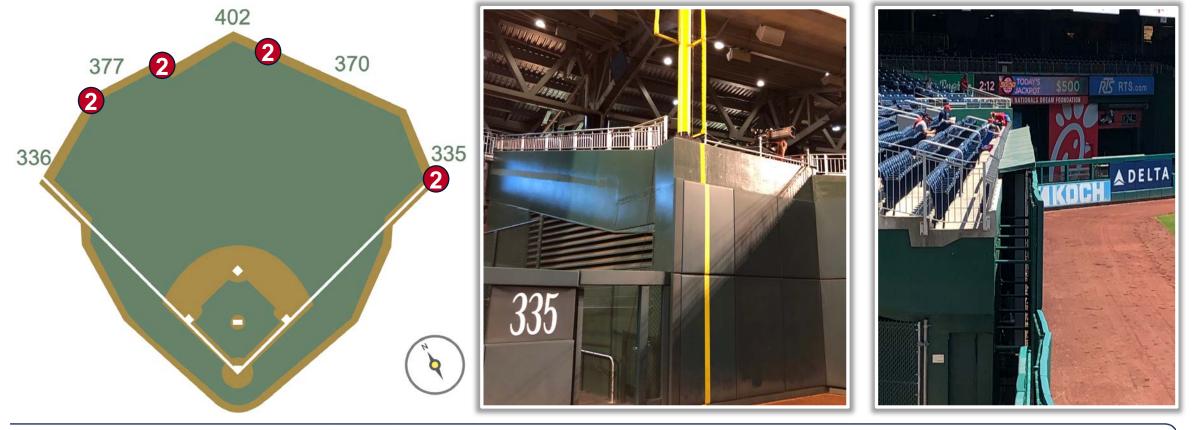
RULE #2: Ball in flight striking the higher wall at a point above the lower wall and bounding over the lower wall: **Home Run**

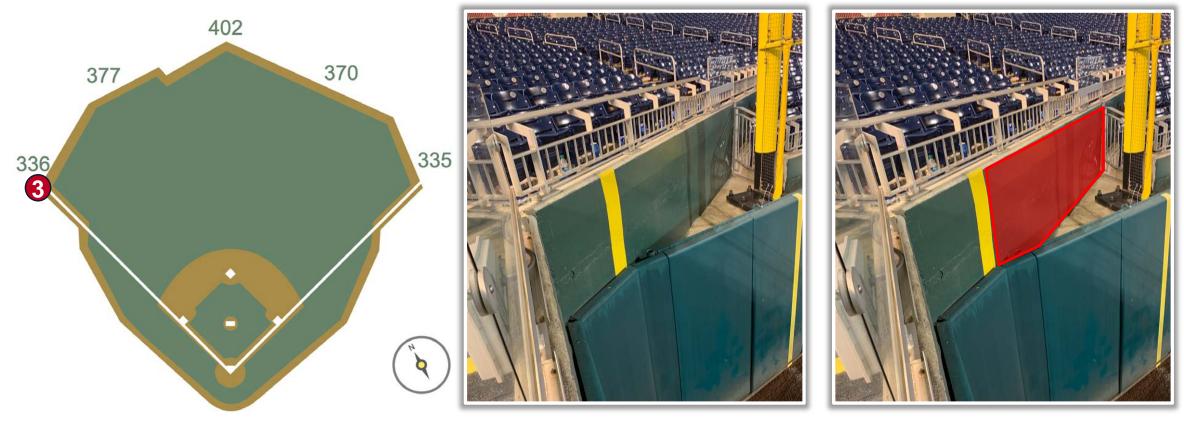
RULE #3: *Fair bounding ball* striking the portion of the wall that is recessed above the padded outfield wall: **Out of Play, Two Bases**

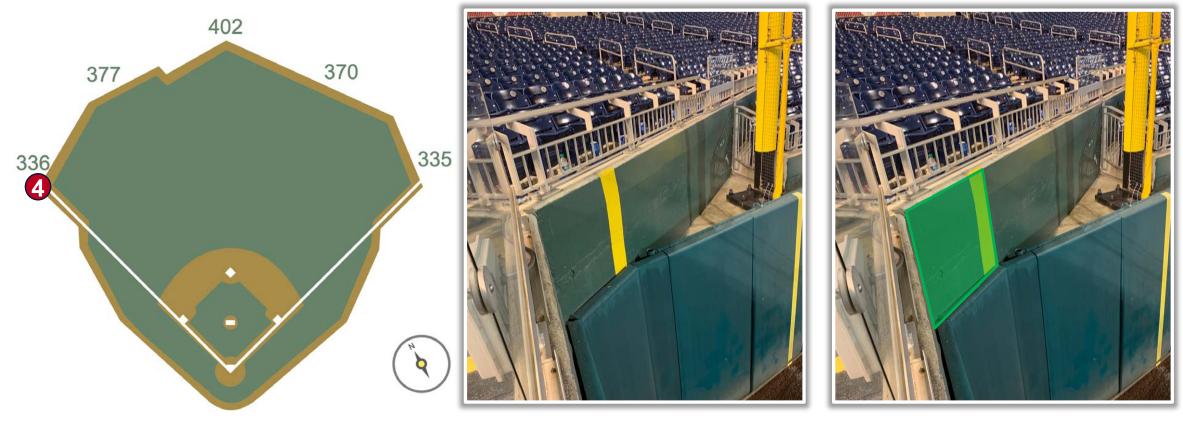
RULE #4: *Fair bounding ball* striking above the padded outfield wall on or to the left of the vertical yellow line in foul territory: **In Play**

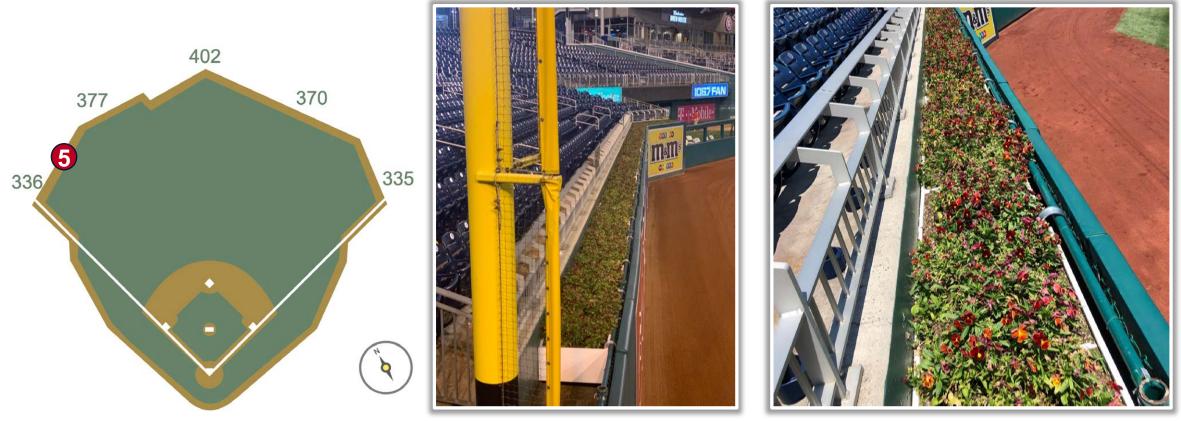
RULE #5: Ball in flight striking beyond outfield fence and landing in the flowerbed or striking the fan safety railing in fair territory: **Home Run**

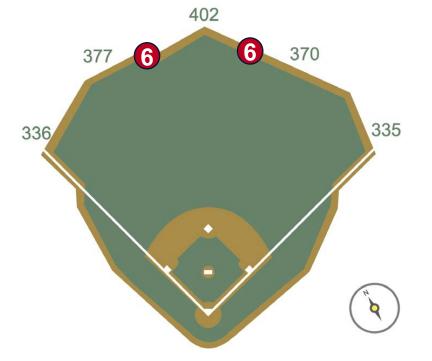
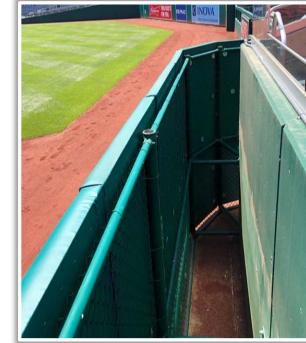
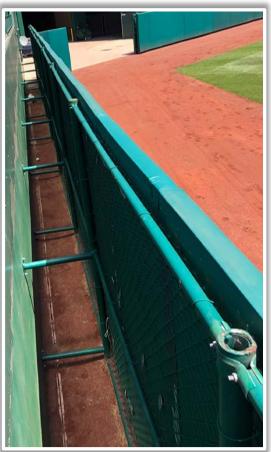
RULE #6: The green metal support pipe on top of the chain-link fence is recessed and behind the outfield wall.

- Ball in flight striking the metal support pipe: Home Run
- Bounding ball striking the metal support pipe: **Out of Play**

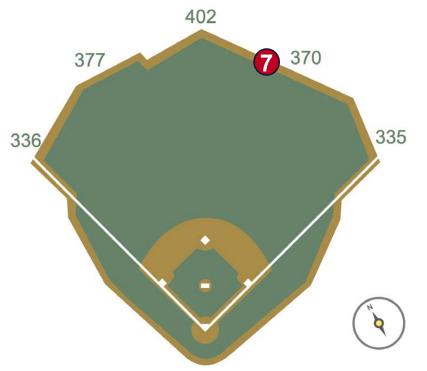
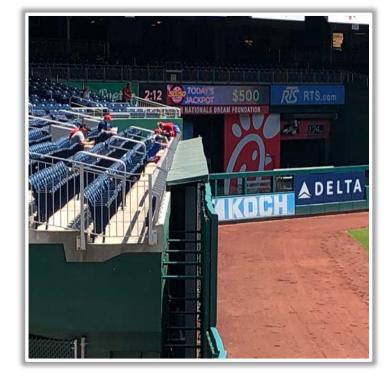
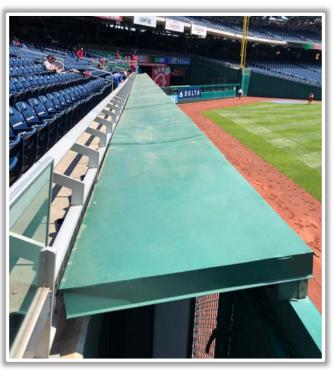
RULE #7: Ball in flight striking the top of the padded surface angled into the stands on top of the out-of-town scoreboard, as well as the plexiglass or fan safety railing, in fair territory: **Home Run**

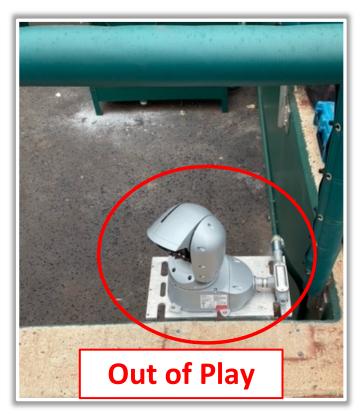
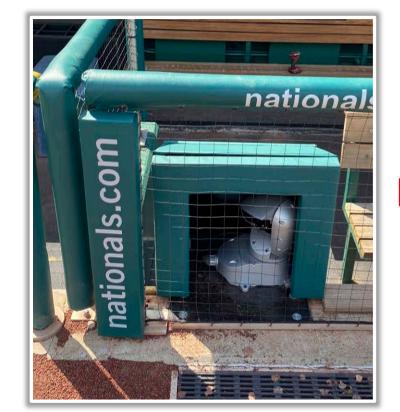
3B iPad Camera Photos:

A ball that strikes the camera behind the netting and enclosed padding is *live and in play* unless it becomes lodged or is otherwise deemed unplayable (i.e. goes completely through the netting).

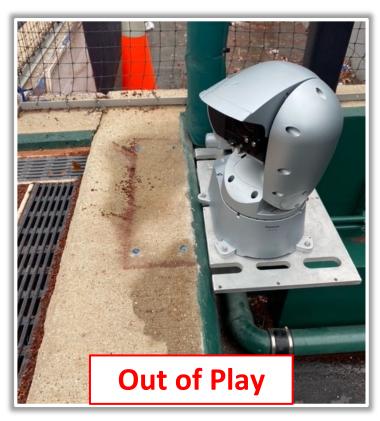
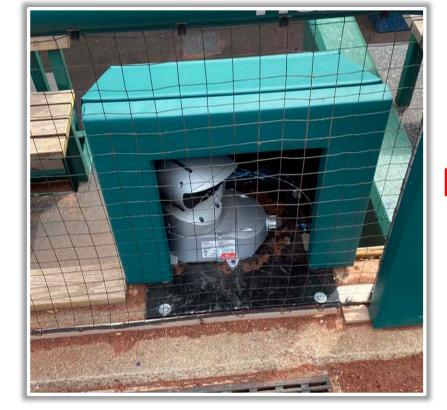
1B iPad Camera Photos:

A ball that strikes the camera behind the netting and enclosed padding is *live and in play* unless it becomes lodged or is otherwise deemed unplayable (i.e. goes completely through the netting).
